Inspection Report

Mine Name: Bingham Canyon Mine
Operator Name: Kennecott Utah Copper
Rohan McGowan-Jackson, Manager

Permit number: M/035/002
Inspection Date: May 5, 2008
Time: 2:00 PM

The purpose of the inspection was to view reclamation progress at the South Tailings Impoundment per the 2007 Reclamation Activities Plan commitments. The commitments included applying crushed limestone, biosolids, fertilizer and seed. Specifically:

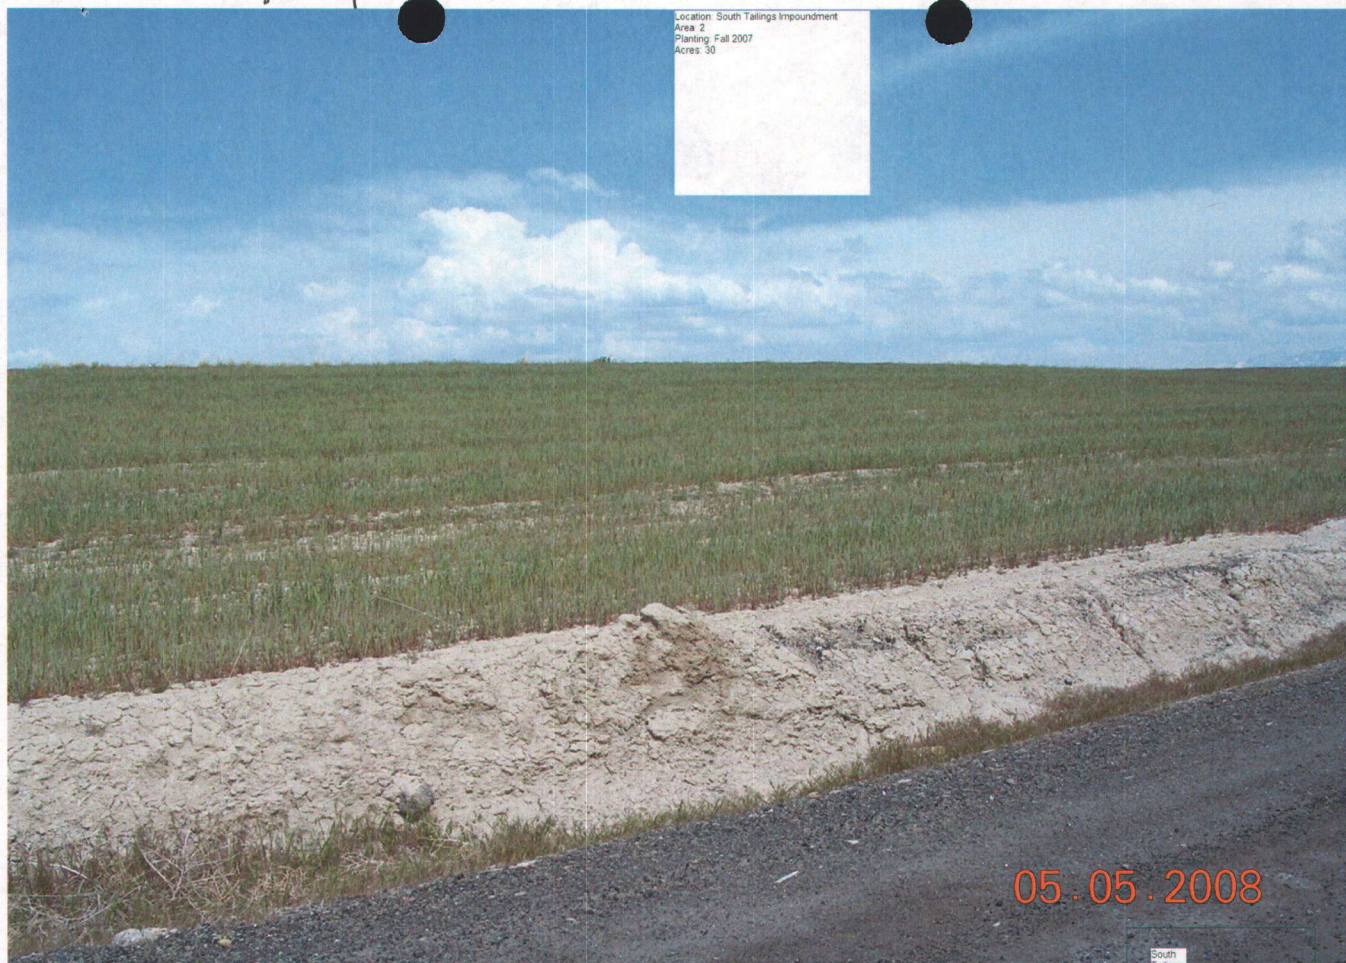
Photo #1

Area two: About 30 acres were fertilized and planted in fall 2007. Mr. Shepherd said there is pretty good success so far. He indicated planting occurs in early spring with completion by the first of April. Mr. Shepherd said using rye in the mix has a dust and erosion control benefit. Cattle were grazing in the area.

Area 2

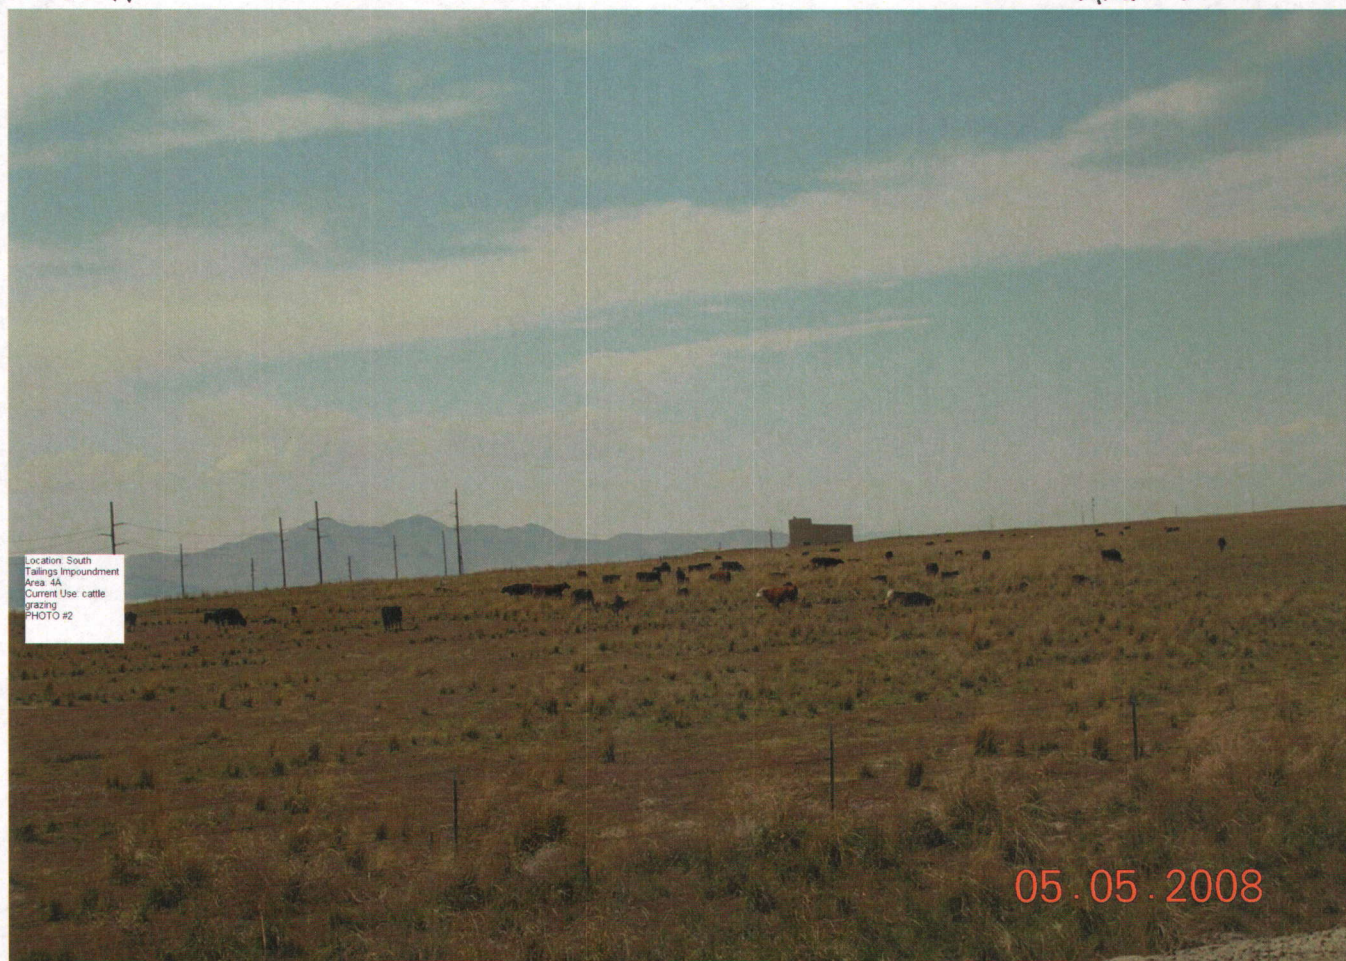
Photo #2

Area 4A

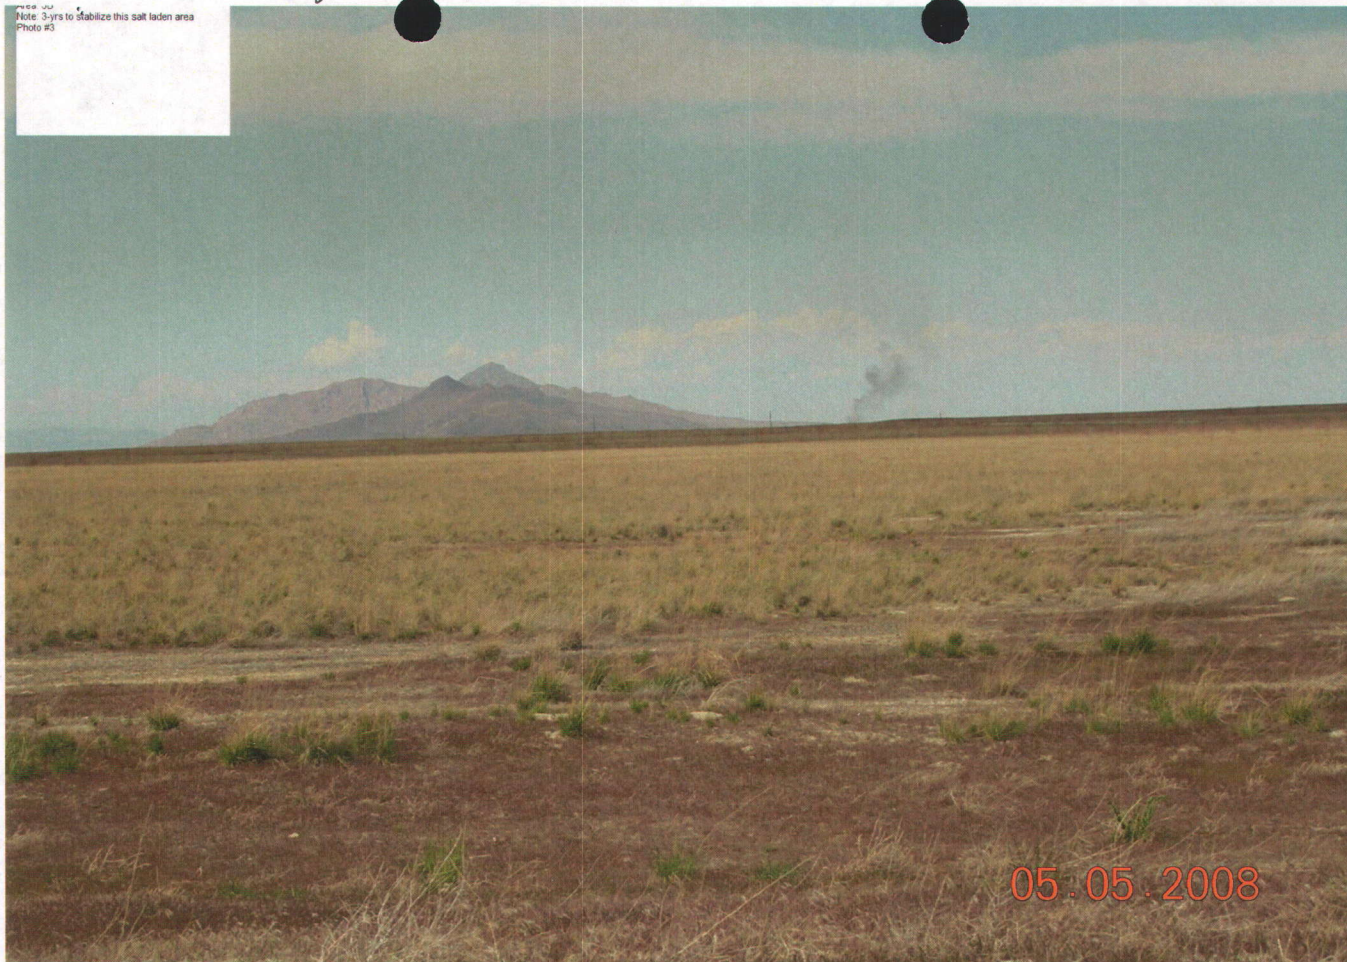
Area 3B
Note: 3-yrs to stabilize this salt laden area
Photo #3

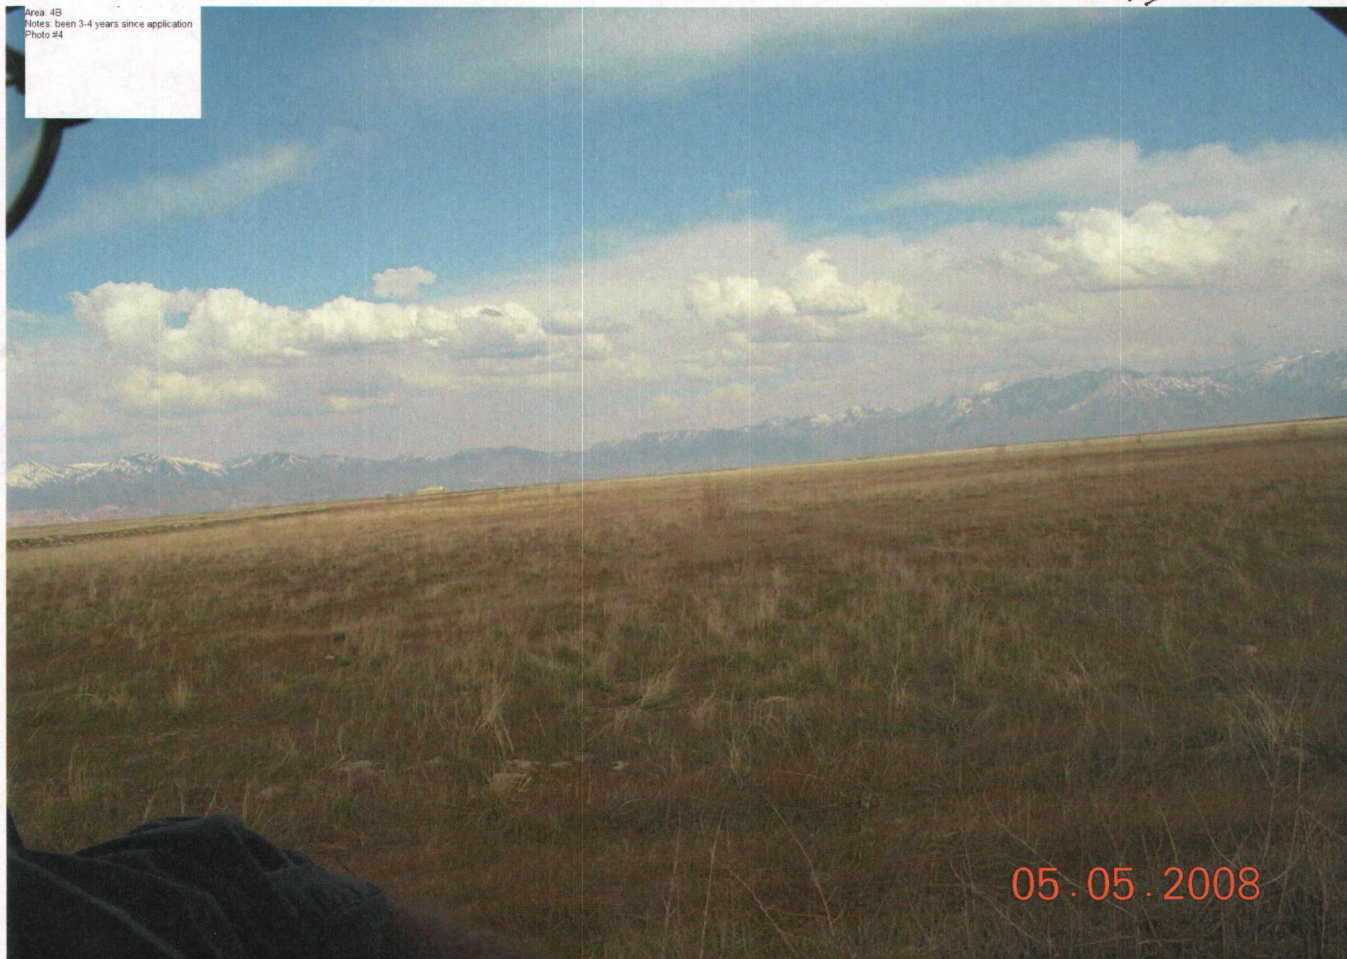
Area 4B
Notes: been 3-4 years since application
Photo #4

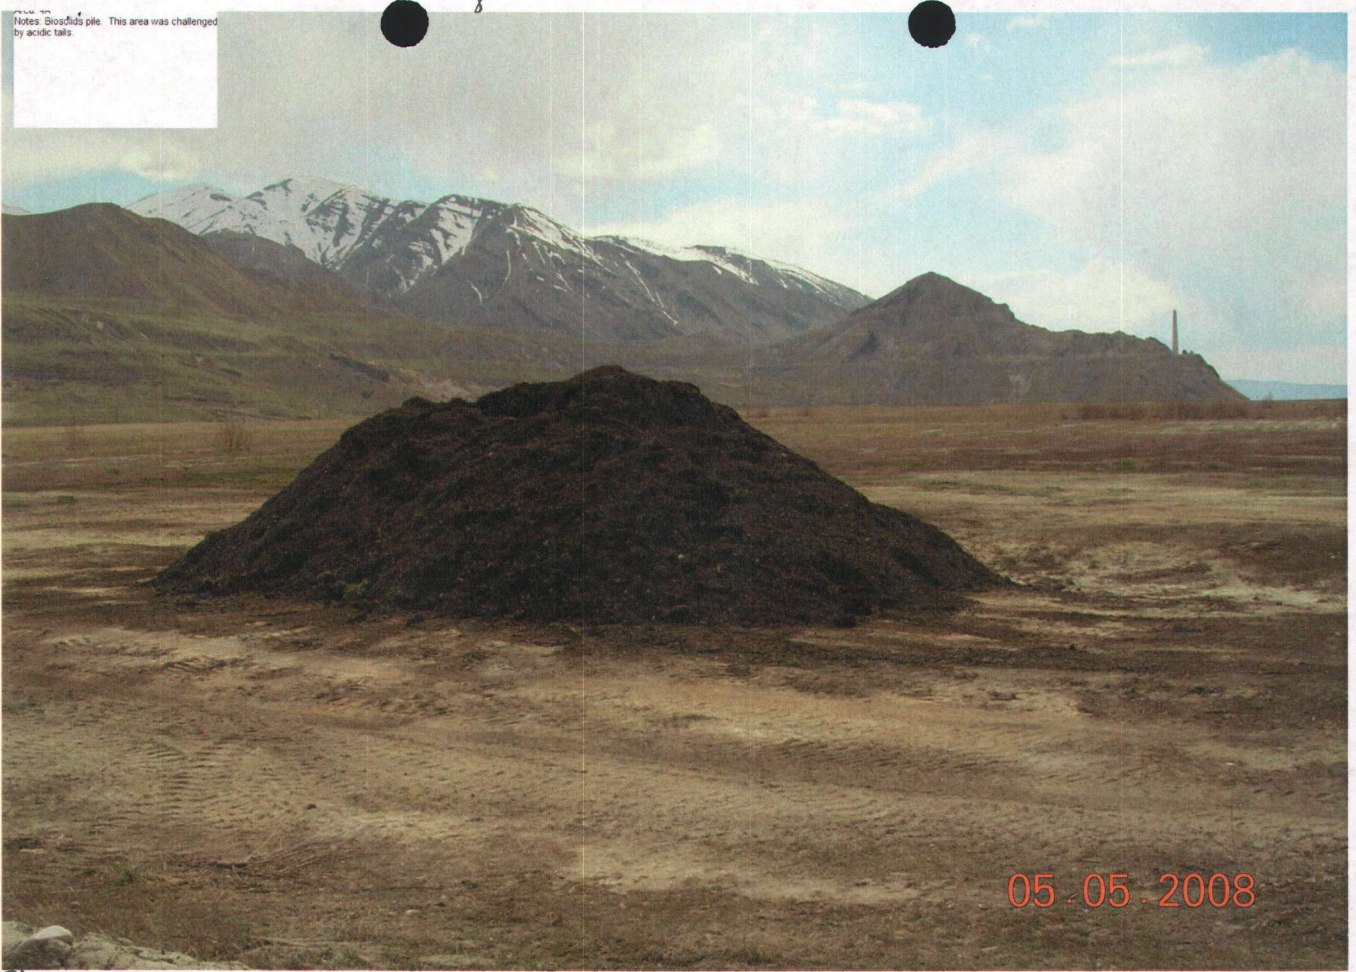
Photo #5

Notes: Biosolids pile. This area was challenged by acidic tails.

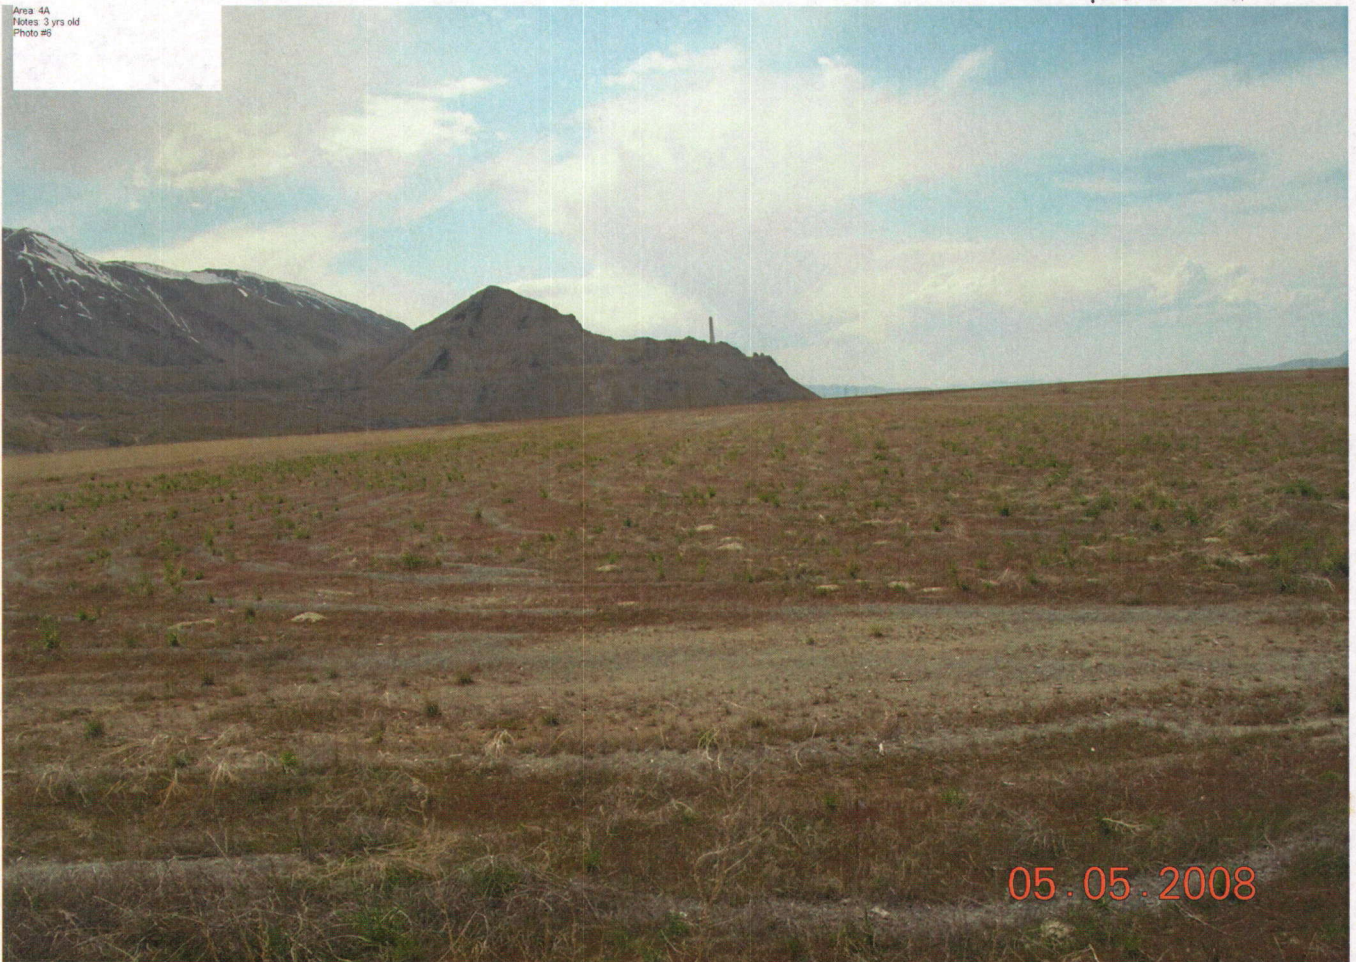
Area 4A
Notes: 3 yrs old
Photo #6

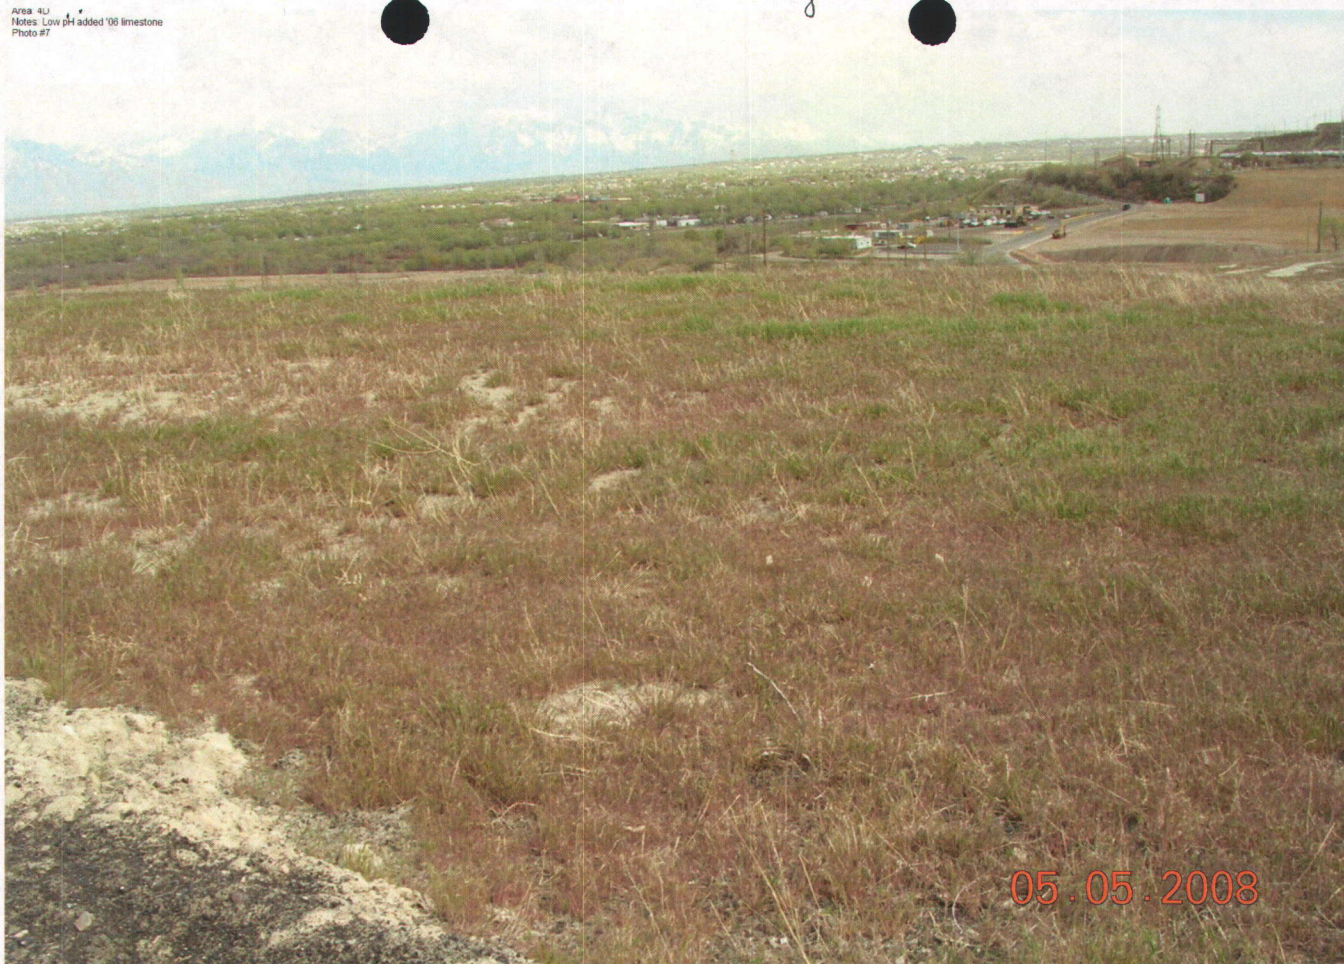
Area 4D
Notes: Low pH added '06 limestone
Photo #7

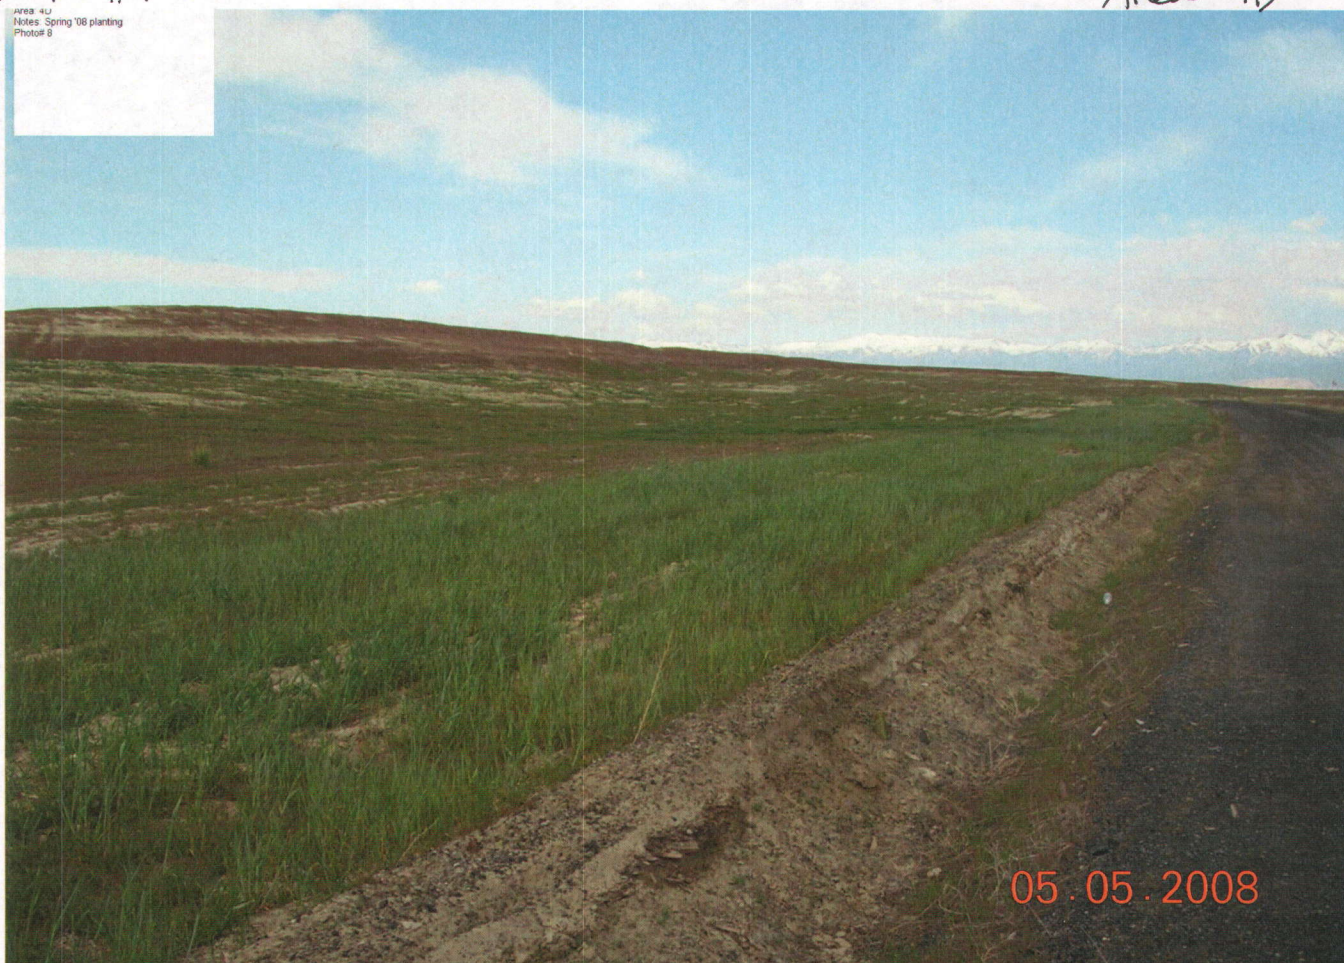
Area four: This segment is high in acidity resulting in a specific reclamation plan. Limestone is applied one year before planting. A portion of this area was planted in spring 2008 as shown in photo #8. Lime was applied in 2006 prior to the spring 2008 planting. Mr. Kaiser indicated that one of the lessons learned is to effectively manage the operations so that tailings success can be achieved with reduced effort. He said it was a complex process, but to ultimately produce better tailings for successful reclamation is important. Mr. Shepherd explained that a 5-acre test plot was established to test the use of hydrate lime. He indicated it brought the pH up by one. Because it reacts quickly, they will mix with the 'slower release' limestone.

Area 4D
Notes: Spring '08 planting
Photo #8

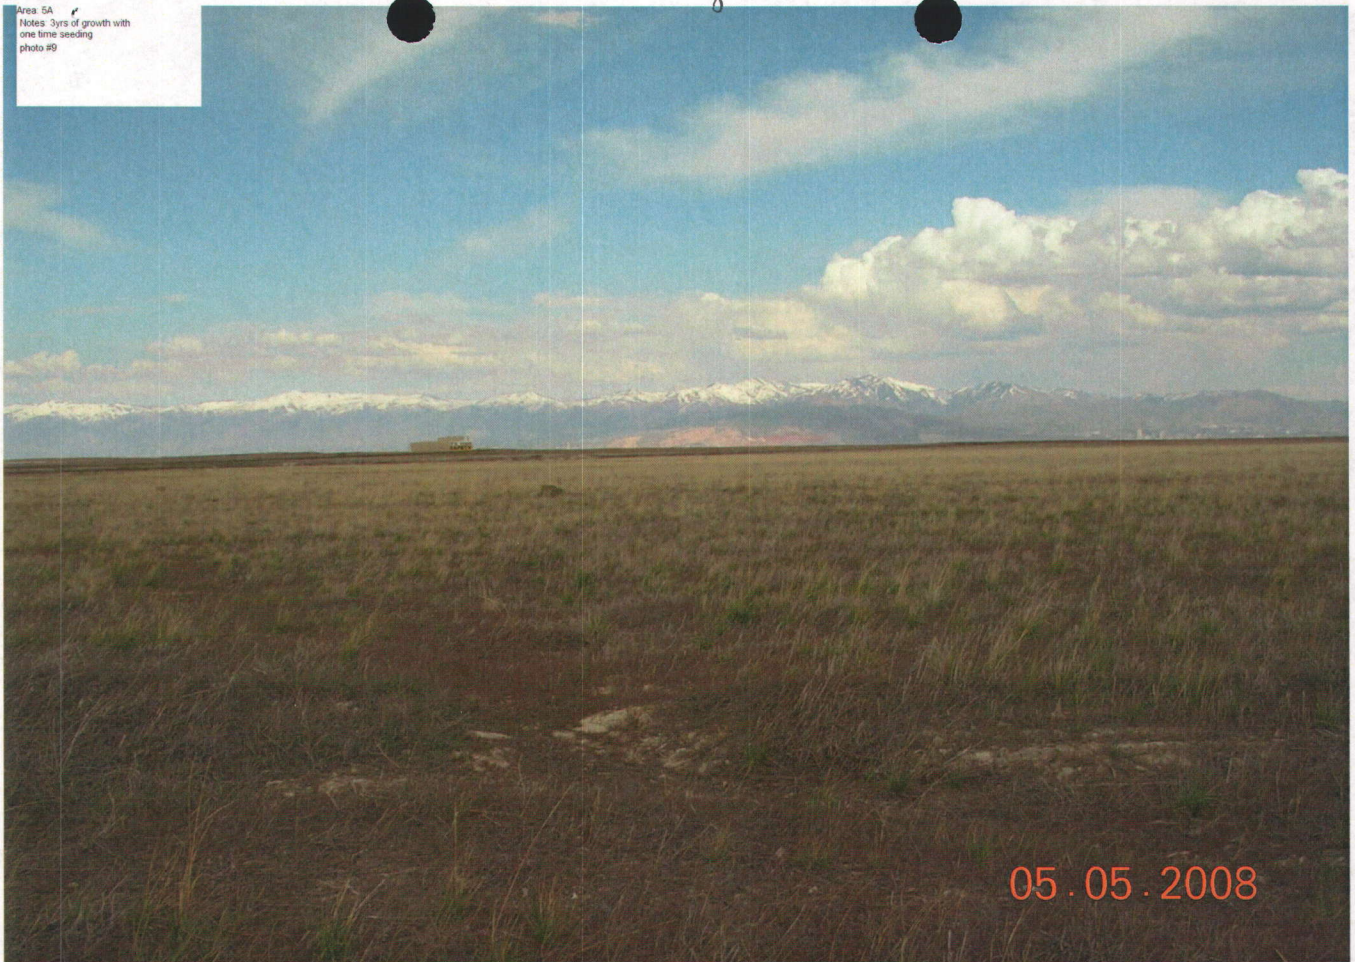
Photo #9

Area five: This north-east section (5E) is the last to dry-out. The area was the last to receive tails, contains slimes, and a shallow depth pond remains. Mr. Shepherd believes it will dry-out in the next two years and the barge can be removed. Birds were seen (photo 11). Mr. Shepherd said the variety of wildlife he's observed are: mice, fat squirrels, skinny raccoons, muskrat, deer, coyote, burrowing owls (but not seen for 2-years), and in '07 a Great Blue Heron. At the south end of segment five, Mr. Shepherd said a one-time seeding occurred about 3 yrs. ago and he considered the revegetation successful (see photo 9).

Area 5A
Notes: 3 yrs of growth with
one time seeding
photo #9

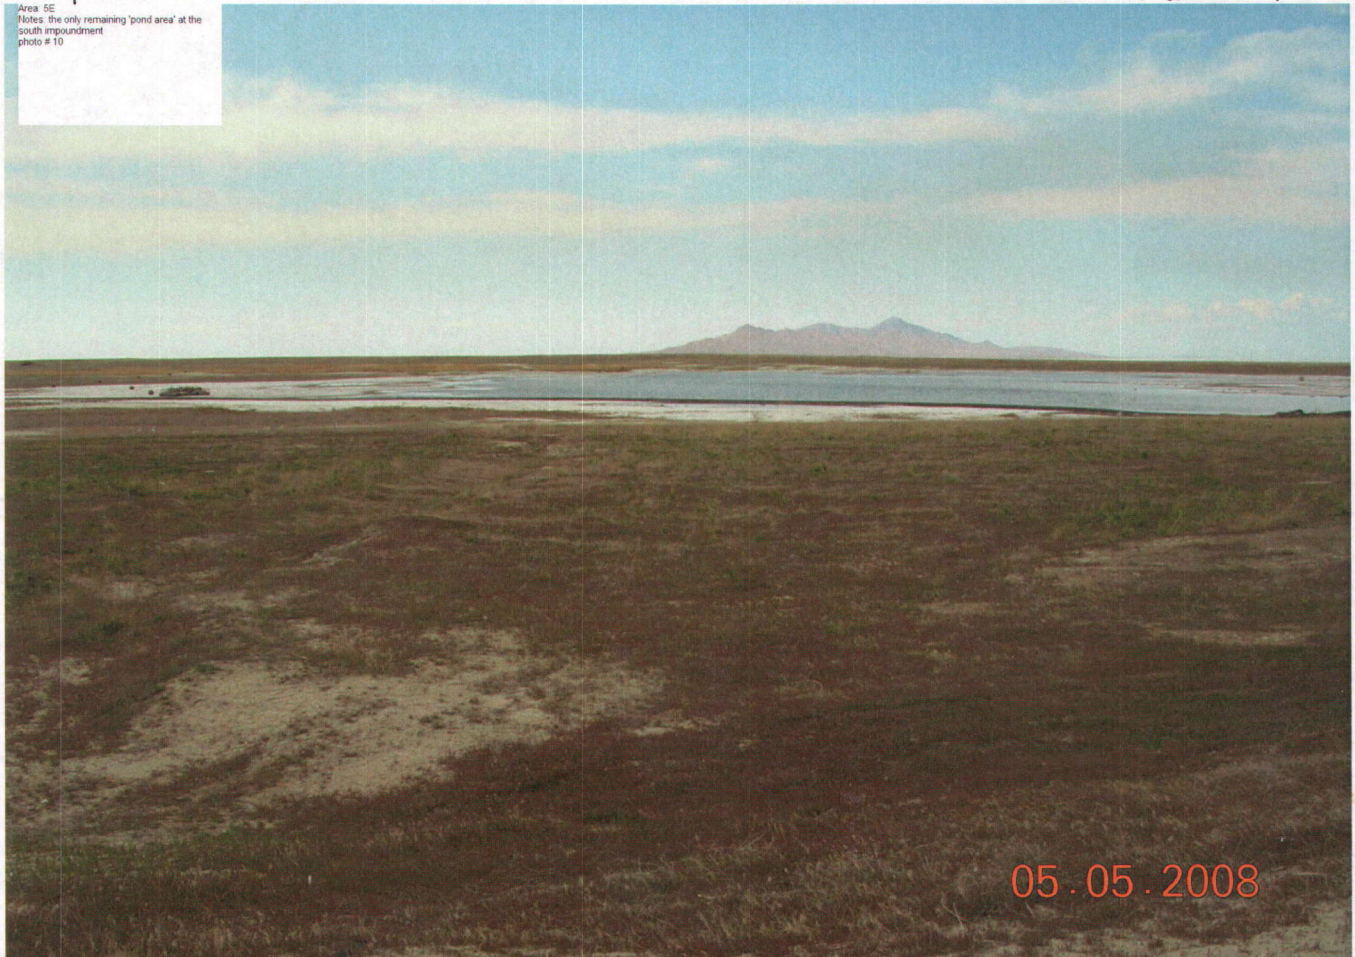
Photo #10

Area 5E
Notes: the only remaining 'pond area' at the
south impoundment
photo # 10

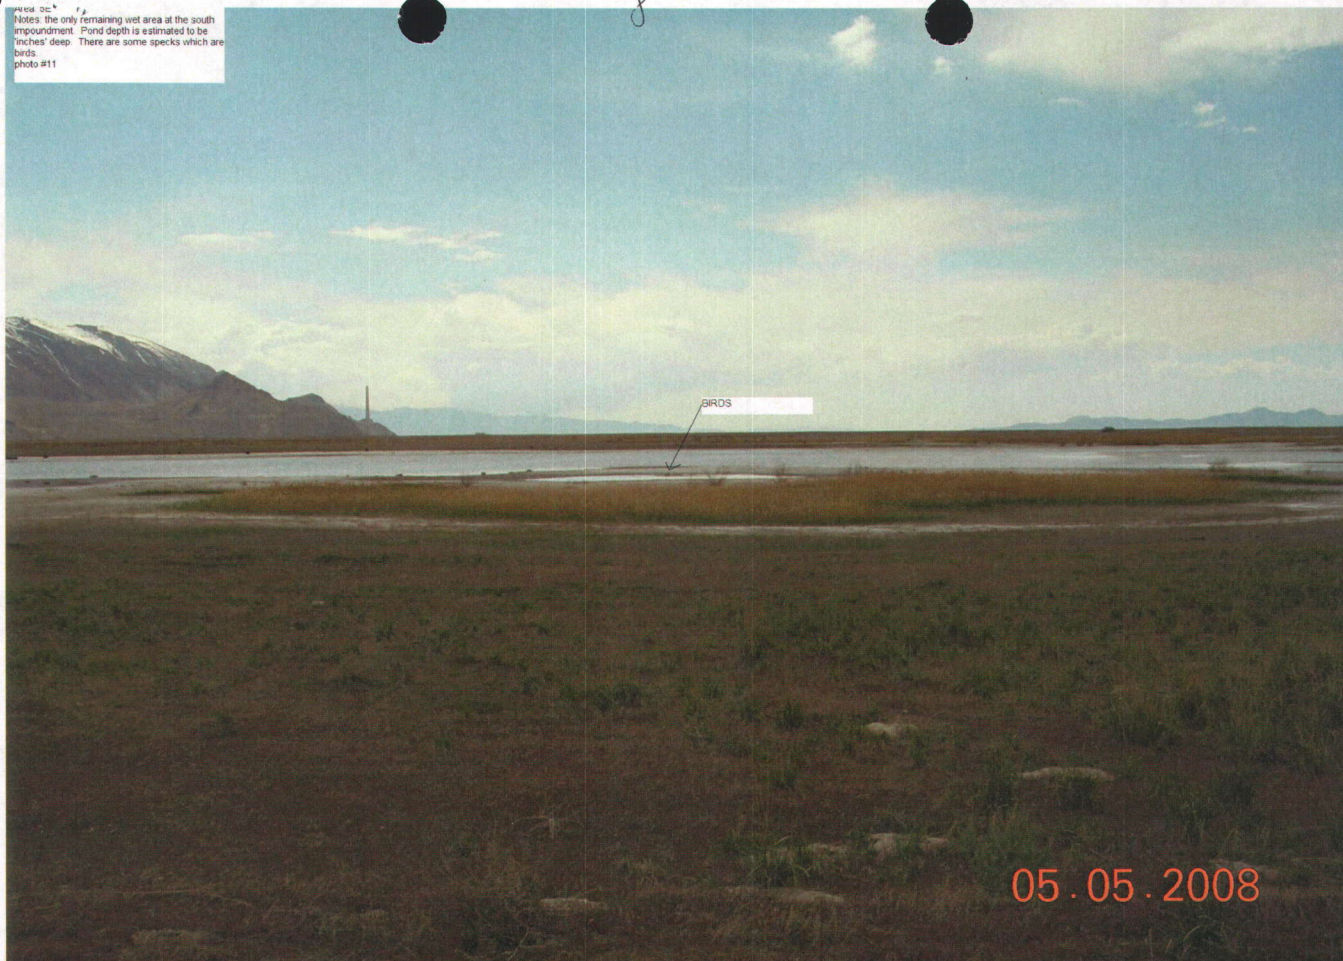
Photo #11

Area 3C
Notes: the only remaining wet area at the south
impoundment. Pond depth is estimated to be
"inches" deep. There are some specks which are
birds.
photo #11

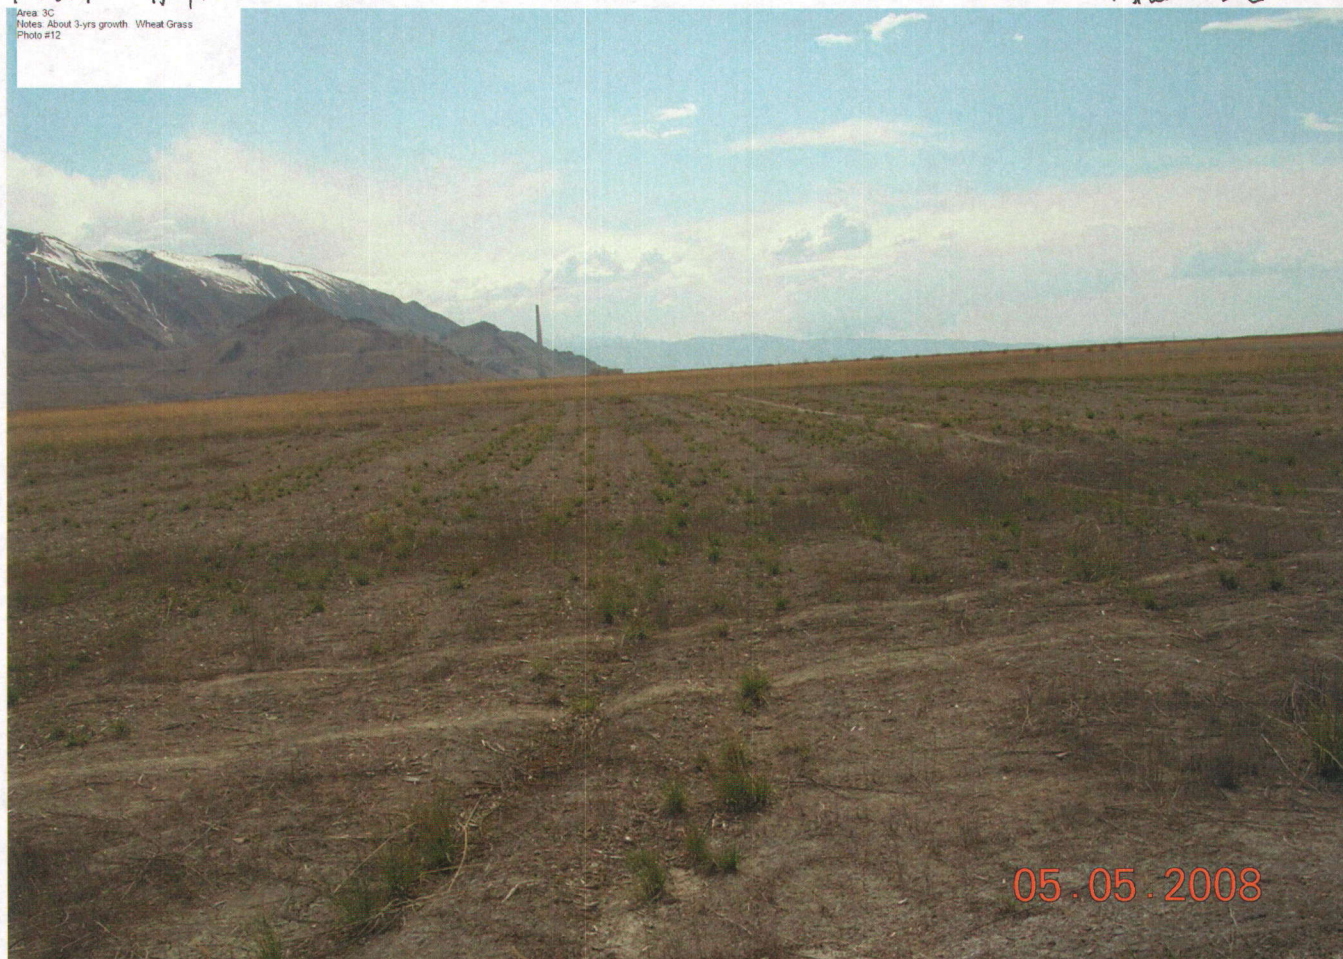
Area three: This section had a high salinity content so has been a challenge to stabilize. Mr. Shepherd expressed that it took about three years to attain stabilization and as shown in photo 12, the wheat grass is about 3-years old.

Area 3C
Notes: About 3-yrs growth. Wheat Grass
Photo #12
